Machinist Dies After Being Struck By Object Thrown From Turning Lathe

MN FACE 97MN028

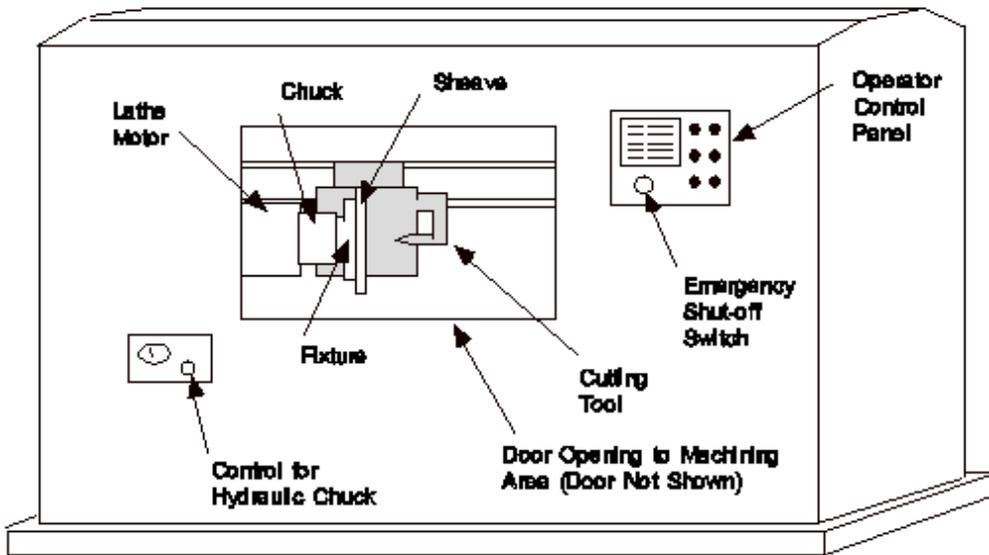
Figure 1. Computer Numeric Controlled (CNC) Lathe (Not to Scale)

On the day of the incident, the victim was setting up a computer numeric controlled (CNC) lathe for a production run of parts that were designed to a customer's specifications. A CNC lathe is a computer program controlled metal turning lathe (Figure 1) that produces finished metal parts or components using computerized controls during the machining process. The lathe had a three jaw chuck that used hydraulic pressure to hold metal stock while it was being machined. The hydraulic jaw pressure was manually set by the operator using an adjustable control knob and pressure gauge located on the front of the lathe. The stock was either held directly by the jaws of the chuck or the stock could be bolted to a metal fixture that was held by the jaws of the chuck. Fixtures were commonly used to hold large and/or irregular shaped items while they were being machined. In this case, a fixture was used to hold an aluminum sheave or disc that was approximately 17 inches in diameter and approximately 1.5 inches thick. The total weight of the fixture and the aluminum sheave was approximately 75 pounds.

The victim bolted an unfinished sheave to a fixture and mounted the fixture in the jaws of the lathe's chuck. The required jaw pressure for machining the aluminum sheaves was 300 pounds per square inch (psi). However, the jaw pressure was set at 170 psi for a parts run that had recently been completed on the lathe and was not increased to the required pressure of 300 psi. After installing the fixture in the jaws of the chuck, the victim closed a sliding door on the front of the lathe that enabled the operator to access the machining area inside the lathe. The victim turned the lathe on and the computer controlled lathe began to machine the sheave by finishing a groove in the outer edge of it. During this portion of the machining process, the fixture and aluminum stock were spinning at approximately 500 revolutions per minute (rpm). Although the jaw pressure was supposed to be set at 300 psi for the entire machining of the sheave, the lower pressure of 170 psi was adequate to hold the fixture and sheave in place while it turned at approximately 500 rpm.

After the outer edge of the sheave was finished, the computer controlled lathe positioned a cutting tool near the center of the spinning sheave to bore a hole in it. Before beginning the center bore, the computer program increased the speed of the chuck to nearly 1500 rpm. When the speed increased, the jaws of the chuck could not securely hold the fixture and sheave because the hydraulic pressure was still set at 170 psi. The victim heard several banging sounds coming from the lathe and attempted to reach an emergency stop switch located on the lathe control panel. The fixture and sheave were thrown from the jaws of the chuck and knocked the access door off the lathe. The victim was struck in the head by the fixture and sheave as it flew from the lathe and was thrown across the manufacturing area. Other workers rushed to aid the victim and immediately placed a call to emergency medical personnel. They arrived shortly after being notified and transported the victim to a local hospital. Later he was transferred to a major medical center where he died two days later.

Note: The lathe's computer program was not capable of changing the hydraulic jaw pressure from 170 psi to 300 psi during the machining of the part. This was a manual setting that was to be made before the lathe was turned on to machine the first item of each production run.

Recommendation #1: Include operator prompts on the lathe control panel screen to ensure all system parameters are properly set.

Recommendation #2: Develop secondary couplers to retain items being machined if the lathe's jaws fail to secure items.
