# Maintenance Worker Electrocuted While Attempting to Change a Light Bulb in Washington State

## FATALITY INVESTIGATION REPORT

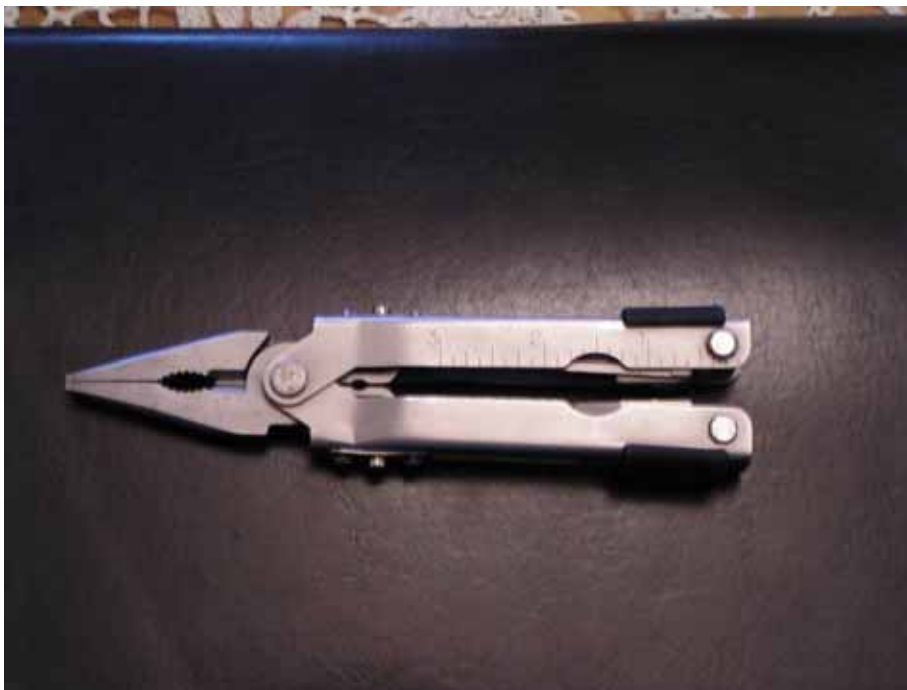
**Photo 4:** This photograph shows the un-insulated multi-tool used by the victim while trying to remove the broken bulb from the light fixture.

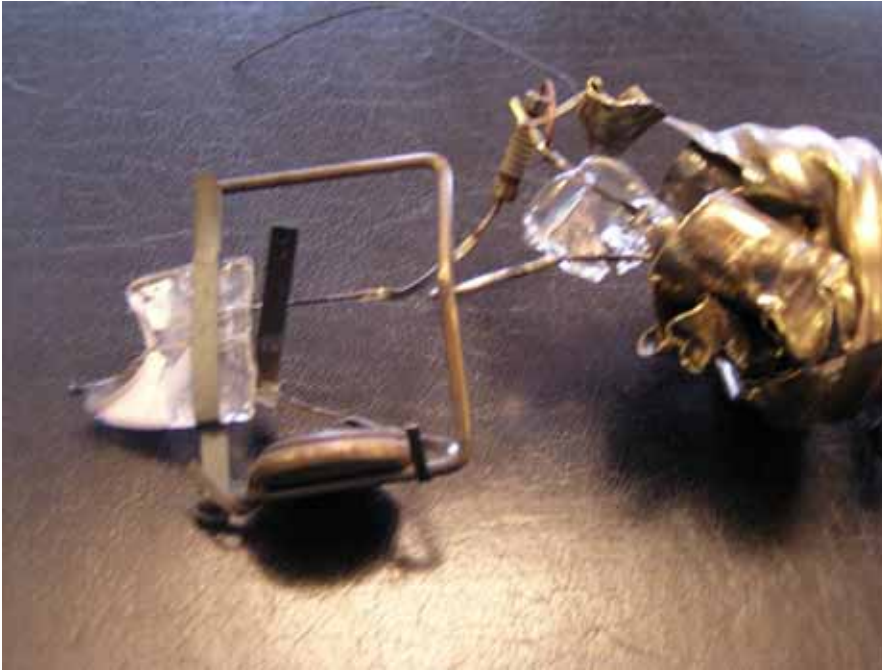
**Photo 5:** Photo of the broken metal halide bulb that the victim was trying to remove from the facility emergency light fixture.

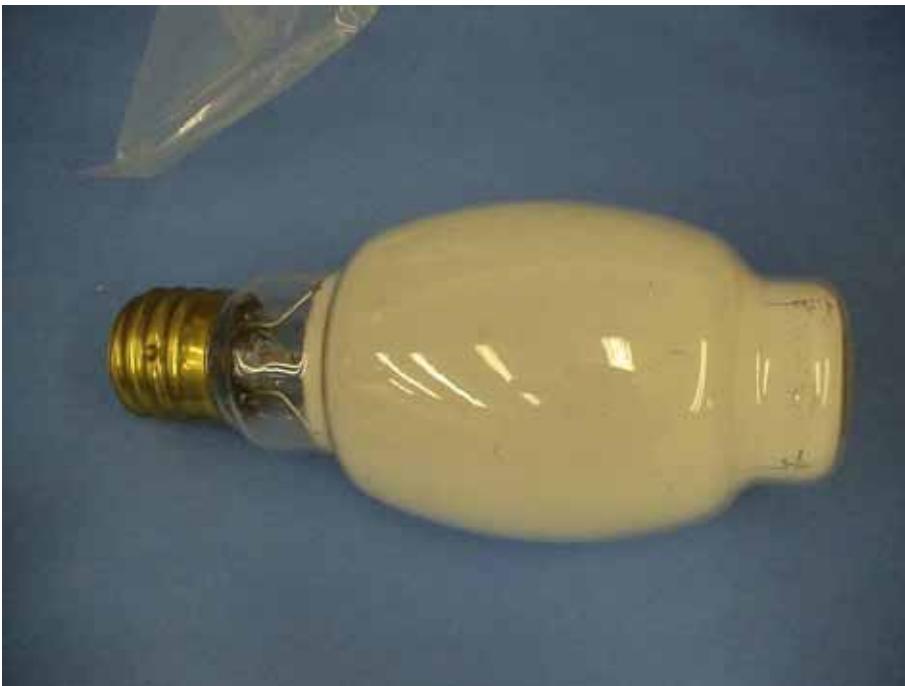
**Photo 6:** This photo shows a new metal halide bulb that the assisted living organization is now using at the facility. The facility no longer keeps the metal halide bulbs on site. They have an electrical contractor come into the facility to replace any metal halide bulbs that are no longer working within their emergency lighting system.
